JANUARY 1982

TELEVISION

**A TV MAN'S GUIDE TO VIDEO
TRIPLER TROUBLES
HIGH DEFINITION TV
SERVICING SKANTIC
CHOPPER CIRCUITS**

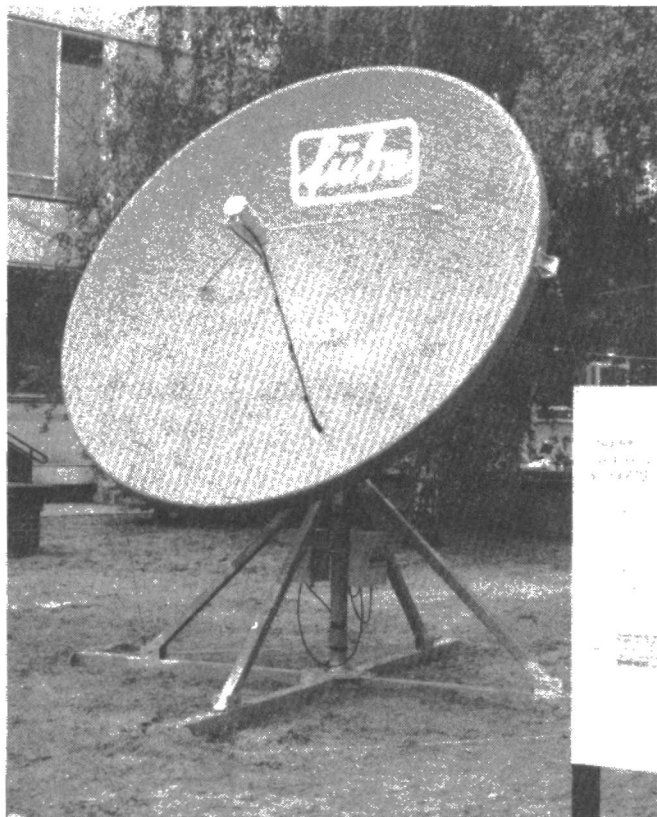
Alexander Wiese writes from Munich: Dish aerals for satellite reception were a feature of the recent Berlin International Audio and Video Fair. Some examples are shown above. At the top left, a Fuba 3m s.h.f. dish. At the top right a 3m dish for u.h.f. reception: this TeKaDe aerial gives wideband coverage with a power gain of 24dB – it's pricey at 15,000 DM. At the bottom are 0.9m s.h.f. dishes from WISI (left) and Kathrein (right). The dish is used to concentrate the signal at the focal point. The actual receiving element may be mounted here or the focused

signal may be reflected back through a hole in the centre of the dish to the receiving element. The latter technique is usually called a Cassegrain aerial – the WISI aerial shown above is of this type (the others have the receiving element at the dish's focal point). A duplexer is required to discriminate between left-hand and right-hand polarisation. The design of duplexers seems to be a problem – only a few firms had usable prototypes on show. Special programmes were sent via the OTS satellite during the Fair so that satellite equipment could be demonstrated working.
